CASE STUDY

RemScan Used in Rapid Response to Diesel Spill

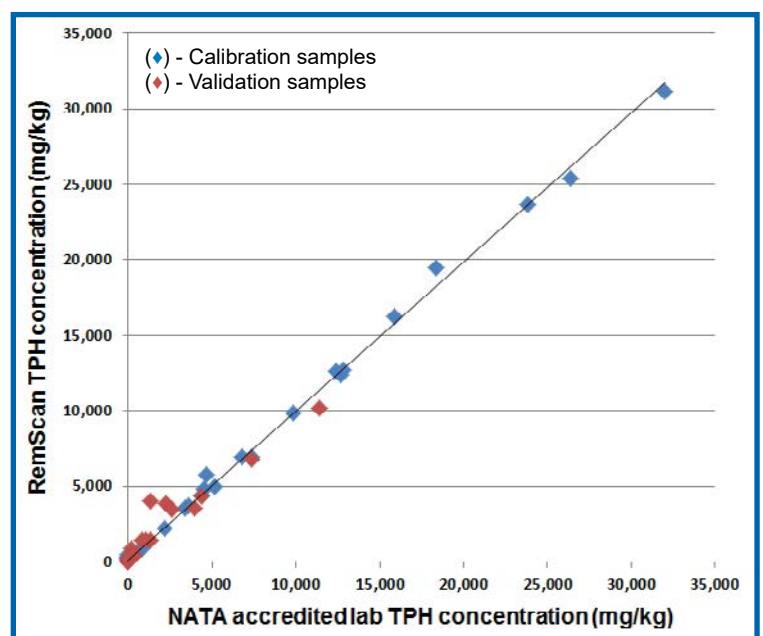
Comparison of RemScan data to lab data for TPH (C₁₀ - C₃₆)

To independently verify the instrument's performance, 19 'blind' soil samples were sent to a NATA-accredited laboratory for analysis. A very close correlation was observed between the TPH values predicted by RemScan and the laboratory data with an R² value of 0.997.
